Re: **Rio Grande Resources Mount Taylor Mine; Major; Individual Permit; SIC 1094: NPDES Compliance Evaluation Inspection; NPDES # NM0028100; July 11, 2018**

NPDES Compliance Inspection Report

**Compliance Evaluation Inspection
Rio Grande Resources/Mt. Taylor Mine
July 11, 2018
NM0028100**

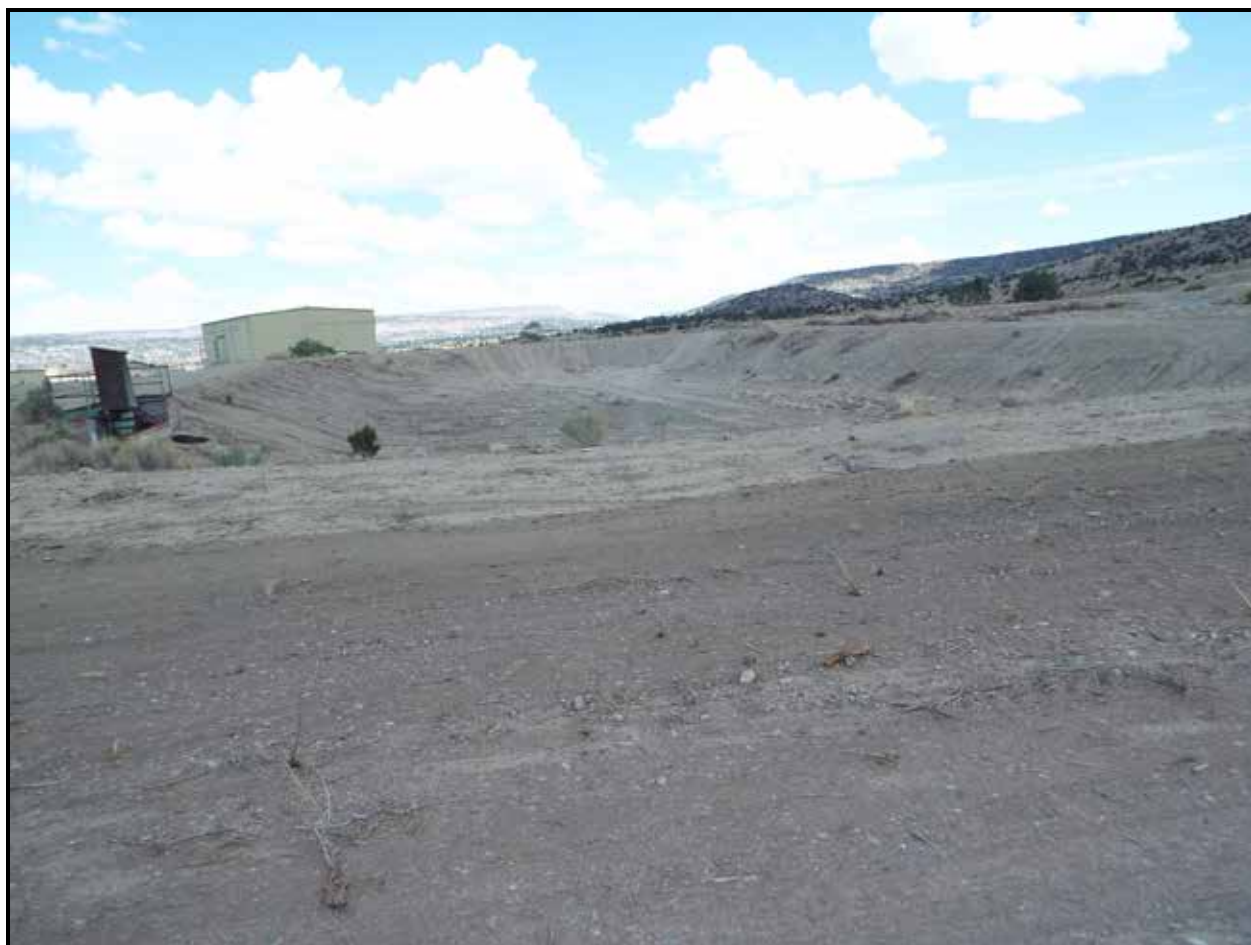
Photo # 1

Photographer: Daniel Valenta	Date: 7/11/2018	Time: 1151 hours
City/County: Mount Taylor Mine, 23 miles north of Milan/Cibola County		
Location: Rio Grande Mount Taylor Mine		
Subject: Holding/settling lagoons are being cleaned and a liner installed.

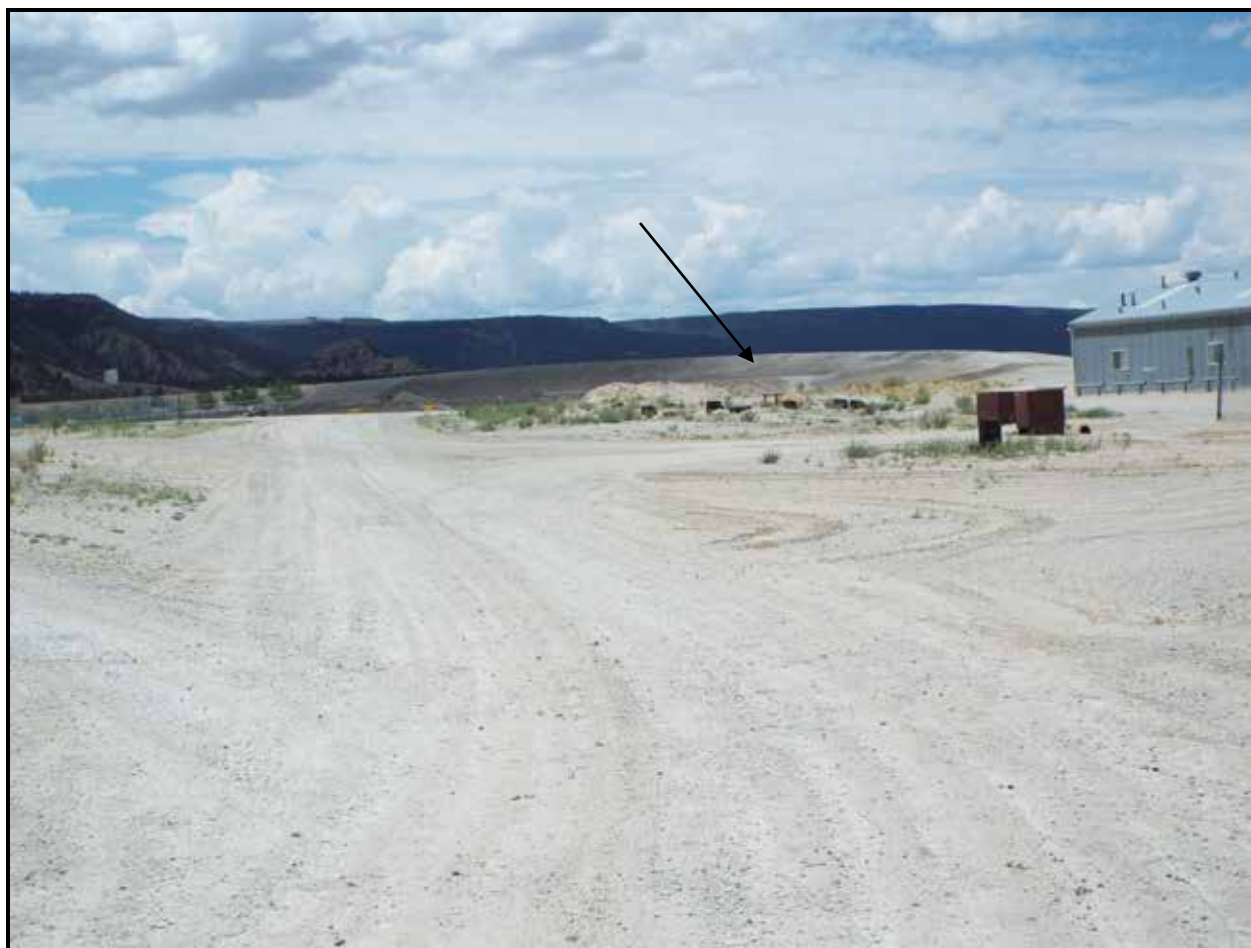
Photo # 2

Photographer: Daniel Valenta	Date: 7/11/2018	Time: 1224 hours
City/County: Mount Taylor Mine, 23 miles north of Milan/Cibola County		
Location: Rio Grande Mount Taylor Mine		
Subject: A new storage/containment structure is being built.

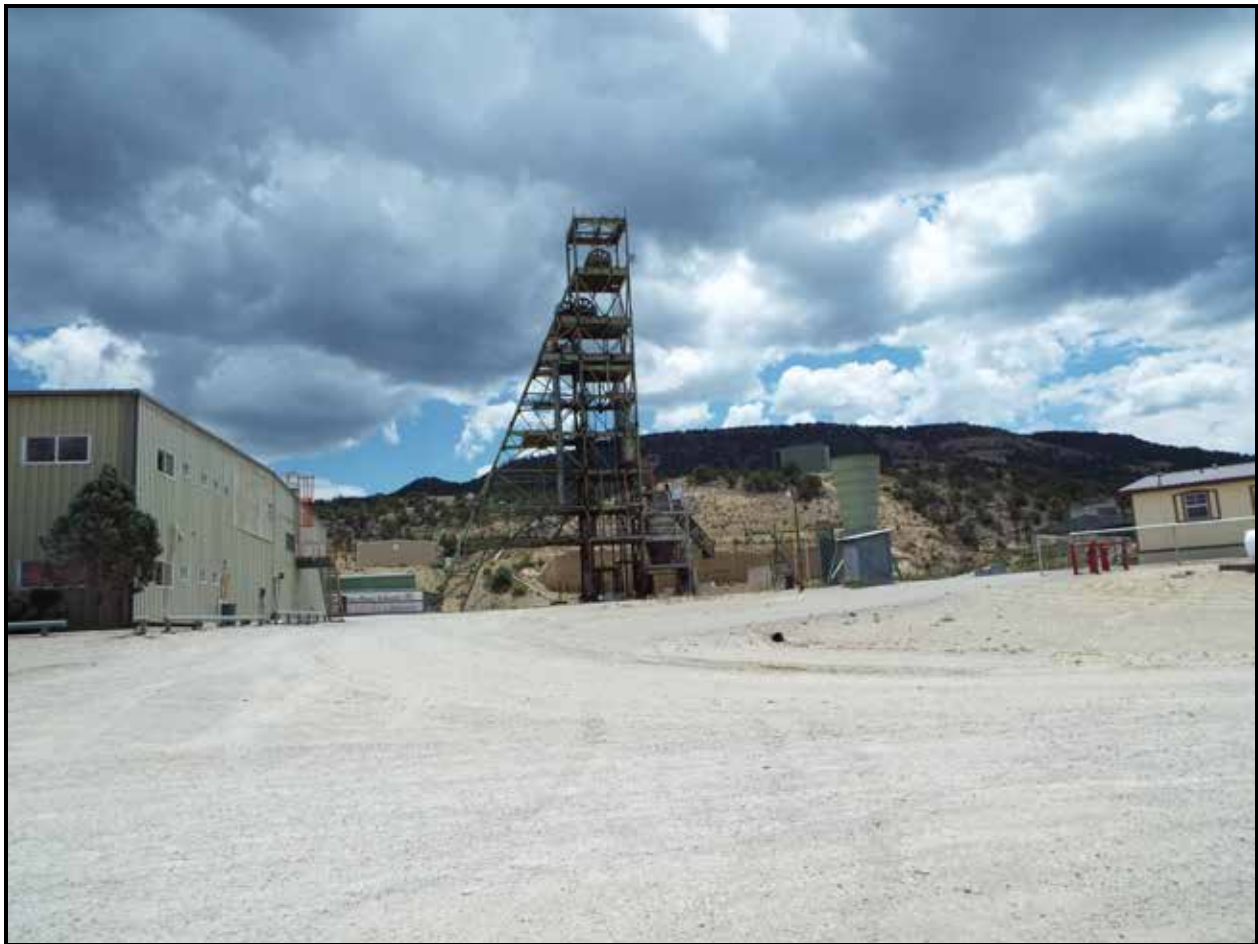
Photo # 3

Photographer: Daniel Valenta	Date: 7/11/2018	Time: 1223 hours
City/County: Mount Taylor Mine, 23 miles north of Milan/Cibola County		
Location: Rio Grande Mount Taylor Mine		
Subject: Mount Taylor headworks.
